BRAKTOOTH: Causing Havoc on Bluetooth Link Manager

VULNERABILITY DISCLOSURE REPORT

August 31, 2021

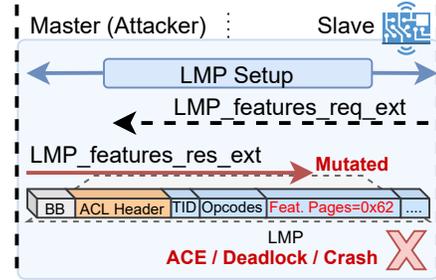
Figure 6: Feature Page Execution

Impact: The attacker is able to execute arbitrary functions implemented in the target ESP32’s firmware. Once the attacker acquires a dump of ESP32 firmware and the memory layout is known, functions at arbitrary addresses can be called.

This allows the attacker to erase user data (NVRAM), call I/O functions that may control actuators, etc. Triggering firmware crashes or a BT deadlock is also possible during repeated attack attempts by executing invalid function addresses. In case of a deadlock, the user needs to manually reset ESP32 to restore BT communications.

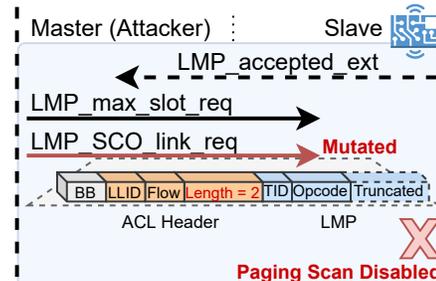
Figure 7: Truncated SCO Link Request

The Bluetooth Classic implementation in the Zhuhai Jieli AC6366C BT SDK 0.9.1 and earlier [35] does not properly handle the reception of truncated LMP_SCO_Link_Request packets while no other BT connections are active. This allows attackers in radio range to prevent new BT connections (disabling the AC6366C inquiry and page scan procedures) via a crafted LMP packet. The user needs to manually perform a power cycle (restart) of the device to restore BT communication. Following Figure 7, the attack can be launched by sending an *LMP_SCO_Link_Request* with *ACL length=2* instead of its normal size of 7.

Impact: The attacker is able to prevent external parties to connect to the device, requiring the user to manually perform a power cycle on the device to resume normal connectivity. Attack risk is reduced if the user is already connected to AC6366C or similar chipsets that only allow one active BT connection at a time.

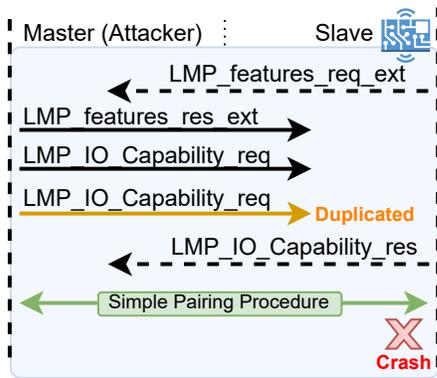
Figure 8: Duplicated IOCAP

The Bluetooth Classic implementation in Espressif ESP-IDF 4.4 and earlier [8] does not properly handle the reception of multiple *LMP_IO_Capability_req* packets during the *pairing process* (see Figure 8). This allows attackers in radio range to trigger memory corruption (and consequently a crash) in ESP32 via a replayed (duplicated) LMP packet. The issue was raised due to the sudden disconnection of ESP32 while its bluedroid host stack was still in the pairing process. The patch provided by Espressif rectifies this issue by handling a sudden disconnection during the pairing procedure (c.f., Table 5).

Impact: The attacker can exploit this vulnerability to promptly cause firmware crashes and therefore maintain a DoS while the attack is taking place. Since ESP32 restarts its firmware by default upon receiving a fault, no user interaction is needed to restore BT communication after the attack is stopped.

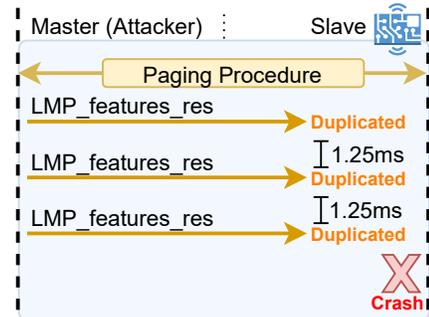
Figure 9: Feature Response Flooding

Impact: The attack triggers a firmware crash on ESP32 and a shutdown on **JBL TUNE500BT** and **Xiaomi MDZ-36-DB**.

In the case of a shutdown, the user needs to manually power on the device again to restore communication. Furthermore, since all targets accept multiple BT connections, the attack can also be triggered while the target is already connected to another device. For example, it is possible to immediately stop audio from playing on **JBL TUNE500BT** and **Xiaomi MDZ-36-DB**. The attacker, however, needs to know the BDAAddress of the target to launch the attack.

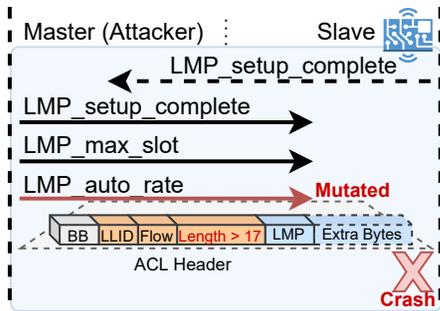
Figure 10: LMP Auto Rate Overflow

Impact: The attack causes a firmware crash on both **WT32i** and **AC6905X**. This can be used to cause a sporadic denial of service (DoS) attacks on such devices.

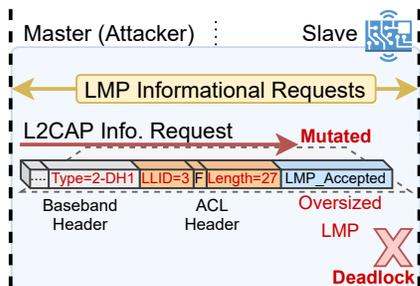
Figure 11: LMP 2-DH1 Overflow

The Bluetooth Classic implementation on Laird CSR8811 A08 [24] and CSR8510 A10 [23] SoCs allows an LMP length overflow over 2-DH1, resulting in a Deadlock (state machine or packet handler corruption) outcome. Figure 11 captures the sequence of messages exchanged to expose this vulnerability.

In particular, the attack is performed by changing the transport type of the normal LMP packet to *2-DH1* and then adding more bytes to the LMP payload. This, for example, results in a total ACL length of 27.

Impact: The attack causes a BT deadlock on Laird CSR8811 and a firmware crash on CSR8510 operating as a standard BT dongle. While the dongle firmware crash is automatically recovered by the OS, the deadlock requires the user to perform a power cycle to restore normal BT communication. The attack does not affect Bluetooth Low Energy (BLE) communication in CSR8811.

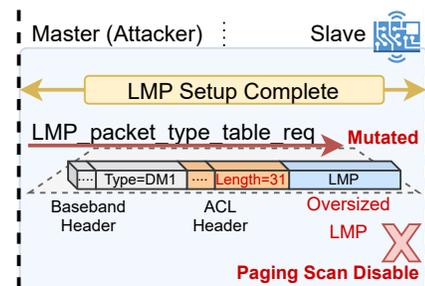
Figure 12: LMP DM1 Overflow

and hence blocks new connections. If the user is already connected to AB5301A and the attack is started (multiple BT connections are allowed), the active connection is not disrupted, but new connections or reconnection is not possible. As compared to V5 (Section 8.5), this attack works with any overflowed LMP packet rather than a specific LMP packet.

Impact: The impact of this attack is similar to V2 (Section 8.2), in which connections to the target are not accepted due to the page scan procedure being disabled after the attack (see Figure 1). Therefore, the user needs to manually perform a power cycle (restart) of the device to restore normal BT connectivity.

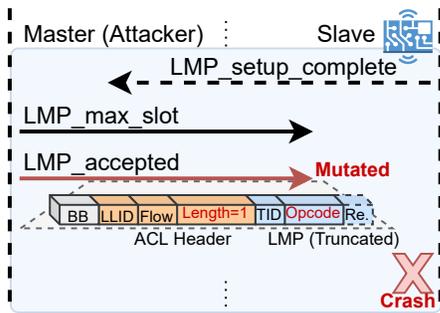
Figure 13: Truncated LMP Accepted

As the BT implementation of the target is closed source, the exact root cause of this vulnerability is not known. However, it is common that LMP procedures involving slot and rate adjustments are usually implemented in an interrupt handler different than other non-real-time LMP packets, such as feature requests and version requests. Such a handler may miss some checks which are present on the other handlers, explaining why some overflow/underflow attacks only work for certain LMP packet opcodes. This split in the LMP handler is present, for instance, in ESP32 BT implementation.

Impact: The impact is a denial of service due to a firmware crash & restart. The overall risk of such an attack is reduced if

AC690X and AC692X do not allow multiple BT connections. In such a scenario, the attacker could only trigger a firmware crash when no user is connected to AC690X or AC692X.

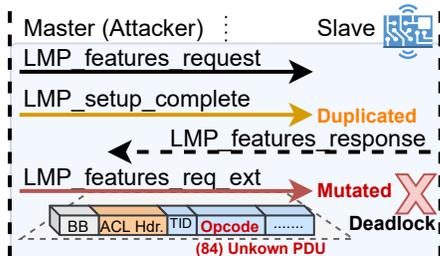
Figure 14: Invalid Setup Complete

This scenario is illustrated in Figure 14. The attacker sends an unexpected (duplicated) *LMP_setup_complete*, followed by a malformed *LMP_features_req_ext* with an invalid LMP opcode such as 0x64. The behaviour seen in Figure 14 allows attackers in radio range to deadlock a device via injecting crafted LMP packets. Moreover, the user needs to manually reboot the device to restore communication.

Impact: An attacker can exploit this vulnerability to perform a DoS. The overall risk of such an attack is reduced if AC690X and AC692X do not allow multiple BT connections.

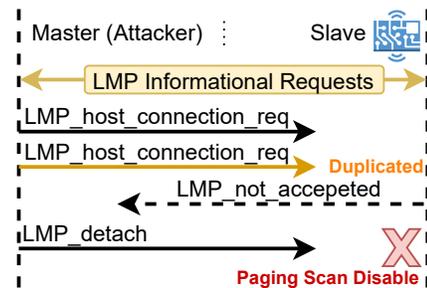
Figure 15: Host Connection Flooding

handle the reception of multiple *LMP_host_connection_req* as shown in Figure 15. This allows attackers in radio range to trigger a denial of service (deadlock) if no user is connected to the target. Manual user intervention is required to restart the device and restore Bluetooth communication.

Impact: An attacker in radio range can exploit the vulnerability to perform DoS and shutdown or restart products using chipsets and products based on Actions ATS2815/ATS2819. However, the impact of the attack is reduced as the vulnerability is only exploited when no other user device is connected to the target.

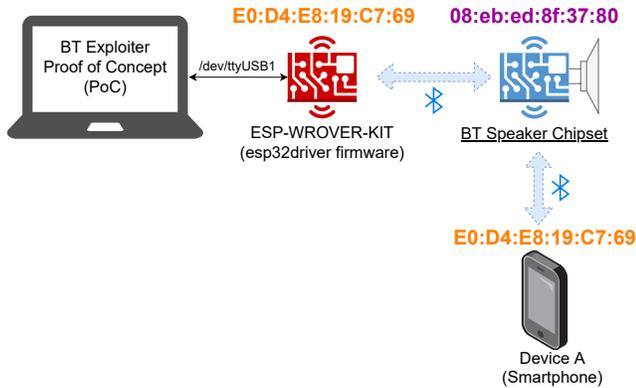
Figure 16: Same Host Connection

When reaching Actions Semi during the disclosure period, the company has informed us that they recommend the product vendors to only allow one audio BT connection. However, when we tested an ATS chipset based product *Xiaomi MDZ-36-DB*, we observed that multiple BT connections are allowed, albeit only one device can play audio at a time. Normally, connections with repeated host BDAAddress are rejected on *LMP Setup* procedure (c.f., Figure 1). However, this procedure is successful when testing *Xiaomi MDZ-36-DB* with repeated host BDAAddress, leading the audio device to an undefined state.

Impact: An attacker in radio range can exploit this vulnerable behaviour to perform DoS and intentionally deadlock the target device.

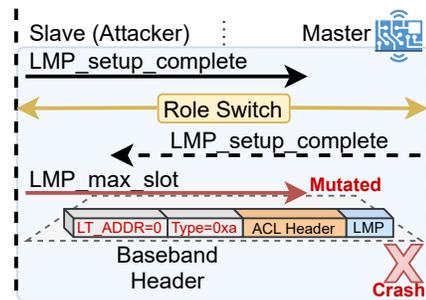
Figure 18: Invalid Max Slot Type

The Bluetooth Classic implementation in the Cypress WICED BT stack 2.9.0 [13] and earlier for CYW20735B1 [12] devices does not properly handle the reception of *LMP_max_slot* with an invalid Baseband packet type and *LT_ADDRESS* (see *Type* and *LT_ADDR* fields in Figure 18). The vulnerability is triggered after completion of the LMP setup procedure,

allowing attackers in radio range to trigger a denial of service (firmware crash) via a crafted LMP packet.

Impact: An attacker in radio range can exploit this vulnerable behaviour to perform DoS and intentionally crash the target device.

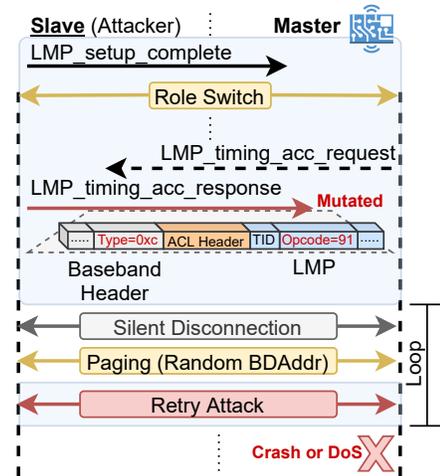
Figure 20: Invalid Timing Accuracy

[30] chipsets do not properly handle the reception of a malformed LMP timing accuracy response followed by multiple re-connections to the target link slave. This allows attackers to exhaust device BT resources. Eventually, the attacker can trigger a crash or BT disturbance via multiple attempts of sending a crafted *LMP_timing_acc_response* (i.e. LMP timing accuracy response) followed by a sudden reconnection to the target with a random BDAAddress.

Impact: This attack causes a denial of service (DoS) attack. Specifically, while the attack is in progress, the target devices are unable to use the Bluetooth service normally.

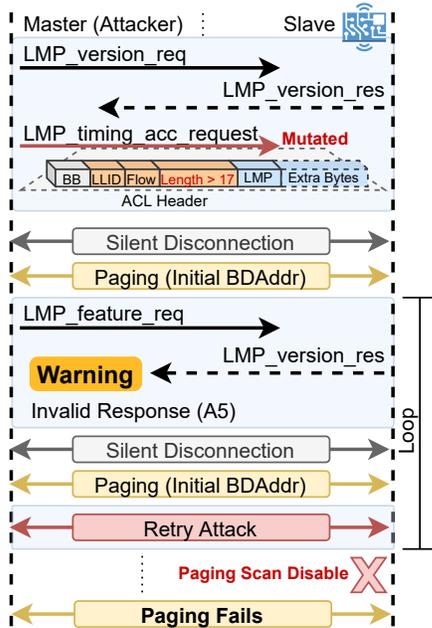
Figure 21: Paging Scan Disable

This vulnerability is depicted in Figure 21. As shown in Figure 21, sending an invalid packet during the LMP timing accuracy procedure (i.e. packet *LMP_timing_acc_request*), followed by a forced re-connection with the same BDAAddress

(any arbitrary BDAAddress of choice of the attacker), leads **Intel AX200** to reject any externally initiated BT connections for an undetermined amount of time. This persists even after the attack stops and requires user intervention to recover **AX200** normal functionalities.

Impact: Once the attack is triggered and successful, the attacker can cause DoS via the following **AX200** behaviours: **(I)** paging scan is disabled, which prevents any external de-

vice to connect to the target even if the BDAddress is known. This behaviour can be used to trick an user to connect to the attacker’s BT hardware instead of the legitimate target since **AX200** paging scan is disabled; **(II)** Multiple active BT connections cannot be performed from the target. The user requires to manually restart the Bluetooth service to restore normal BT behaviour. On Linux and Windows, BT is recovered by disabling and enabling Bluetooth via their respective configuration menu.

Firmware crashes may be sporadically triggered on **AX200** during the attacks, but no specific scenario was found to reliably trigger such crashes all the time.
