Hunting down the HVCI bug in UEFI

Jan 15, 2024

This post details the story and technical details of the non-secure Hypervisor-Protected Code Integrity (HVCI) configuration vulnerability disclosed and fixed with the January 9th update on Windows. This vulnerability, [CVE-2024-21305](#), allowed arbitrary kernel-mode code execution, effectively bypassing HVCI within the root partition.

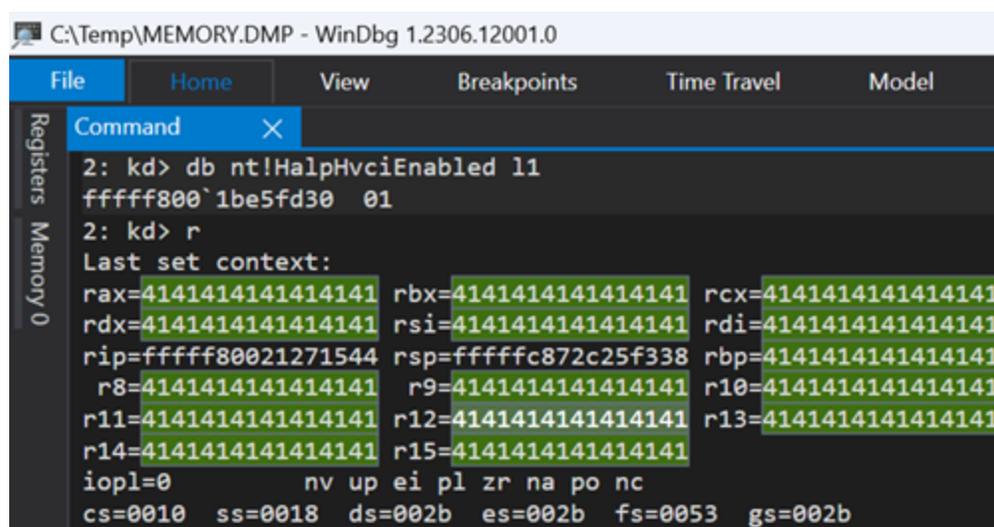
Exploiting this issue for a verification purpose was trivial as the RWX GPAs did not change across reboot or when test-signing was enabled. I wrote the driver that remapped a choice of linear address onto one of RWX GPAs and placed shellcode there, and was able to execute the shellcode as expected! If HVCI were working as intended, the PoC driver would have failed to write shellcode and caused a bug check. For more details on the PoC, see [the report on GitHub](#).

```
C:\Temp\MEMORY.DMP - WinDbg 1.2306.12001.0
File Home View Breakpoints Time Travel Model
Registers Memory 0
Command X
2: kd> db nt!HalpHvciEnabled 11
fffff800`1be5fd30 01
2: kd> r
Last set context:
rax=4141414141414141 rbx=4141414141414141 rcx=4141414141414141
rdx=4141414141414141 rsi=4141414141414141 rdi=4141414141414141
rip=fffff80021271544 rsp=fffffc872c25f338 rbp=4141414141414141
r8=4141414141414141 r9=4141414141414141 r10=4141414141414141
r11=4141414141414141 r12=4141414141414141 r13=4141414141414141
r14=4141414141414141 r15=4141414141414141
iopl=0          nv up ei pl zr na po nc
cs=0010  ss=0018  ds=002b  es=002b  fs=0053  gs=002b
```
