BRAKTOOTH: Causing Havoc on Bluetooth Link Manager

VULNERABILITY DISCLOSURE REPORT

August 31, 2021

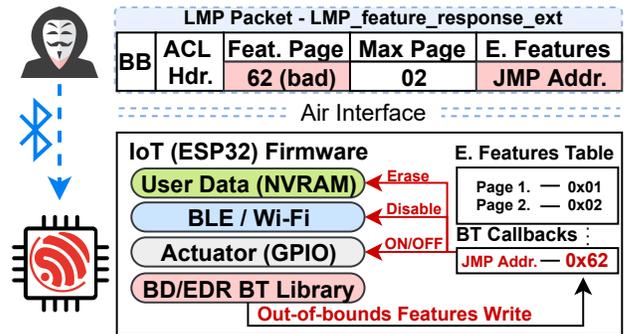
Figure 3: An Illustration of CVE-2021-28138.

The most critical vulnerability (V1 in Table 2 - 8.1) affects ESP32 SoC [32], which is used in many Wi-Fi and Bluetooth IoT appliances such as Industry Automation, Smart Home, Fitness, etc. The attack is illustrated in Figure 3. A lack of out-of-bounds check in ESP32 *BT Library* [10] allows the reception of a *mutated LMP_feature_response_ext*. This results in the injection of eight bytes of arbitrary data outside the bounds of *Extended Feature Page Table* ("E. Features Table" in Figure 3). An attacker, which knows the firmware layout of a target device, can write a known function address (*JMP Addr.*) to the offset pointed by *Features Page* ("Feat. Page" in the *LMP_feature_response_ext* packet) field. It turns out that the *BT Library* stores some callback pointers within the out-of-bounds *Features Page* offset and such a callback is even-

tually invoked during the BT connection. While exploiting this vulnerability, we forced ESP32 into erasing its NVRAM data (normally written during product manufacturing) by setting *JMP Addr.* to the address of *nvs_flash_erase*. Such erase function is always included in ESP32 SDK [8] and therefore, it is present in any ESP32 firmware. Similarly, disabling BT or BLE can be done via *esp_bt_controller_disable* and Wi-Fi via *disable_wifi_agc*. Additionally, general-purpose input/output (GPIO) can be controlled if the attacker knows addresses to functions controlling actuators attached to ESP32. As expected, this has serious implications if such an attack is applied to Bluetooth-enabled Smart Home products.

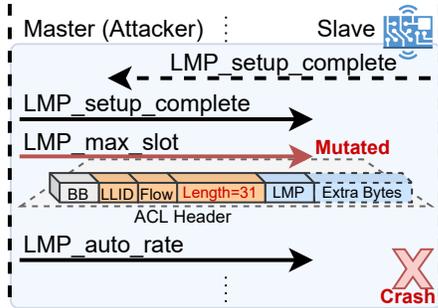
Figure 19: Max Slot Length Overflow

The Bluetooth Classic implementation in the Cypress WICED BT stack 2.9.0 [13] and earlier for CYW20735B1 [12] devices does not properly handle the reception of *LMP_max_slot* with a higher ACL Length (*Length=31* as shown in Figure 19) after completion of the LMP setup procedure. This allows attackers in radio range to trigger a denial of service (firmware crash) via a crafted LMP packet.
